[Docket No. 94-NM-28-AD; Amendment 39-9292; AD 95-13-12]

#### **Airworthiness Directives; Boeing Model 767 Series Airplanes Equipped With General Electric CF6-80C2 Series Engines**

**ACTION:** Final rule.

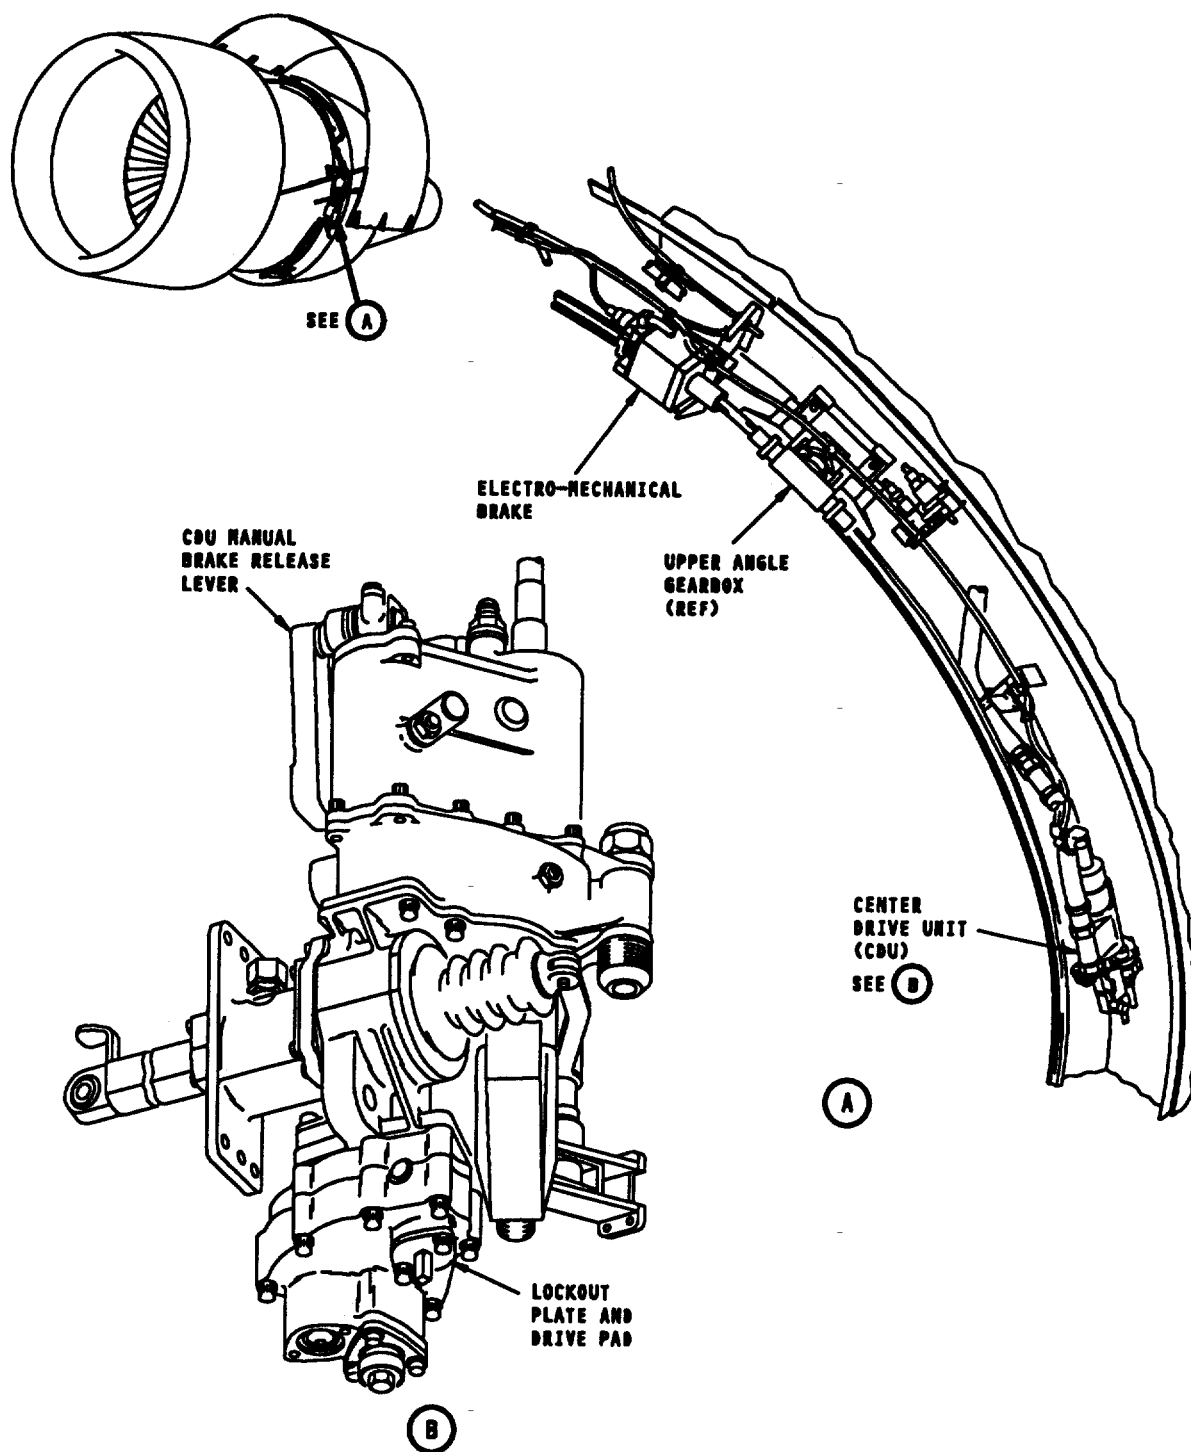
Electro-Mechanical Brake and CDU Cone Brake Torque Check  
Figure 1

#### 2. Electro-Mechanical Brake and CDU Cone Brake Torque Check (Fig. 1)

(1) The electro-mechanical brake system is working correctly if the torque is reached before you turn the wrench 450 degrees (1-1/4 turns).

(2) If the flexshaft turns more than 450 degrees before you reach the specified torque, you must replace the long flexshaft between the CDU and the upper angle gearbox.

(3) If you do not get 90 pound-inches of torque, you must replace the electro-mechanical brake.

(1) If the wrench does not return to within 30 degrees of initial starting point, you must replace the long flexshaft between the CDU and upper angle gearbox.

(a) If the torque is less than 15 pound-inches, you must replace the CDU.
